Manhole Inspection Summary

Manhole # S11YY1011MH

Insp Date: **7/18/06 10:19 AM**

Location Address: **5602 EVERTON RD** Cross Street: **ROCKSPRING RD**

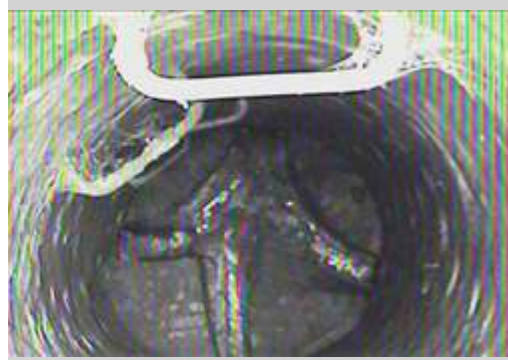
Top View

Corroded steps. Bench debris.

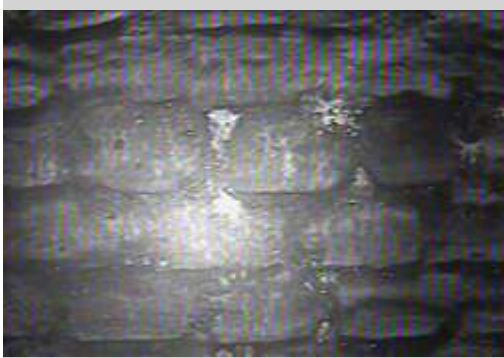
Defect

Barrel infiltration.

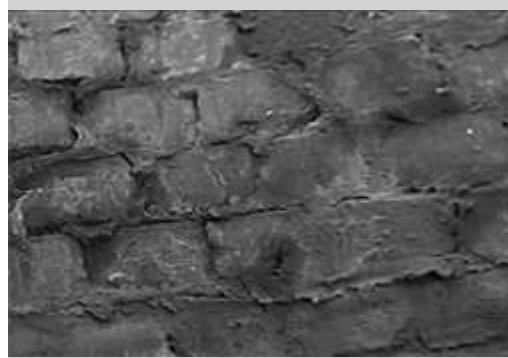
Defect

Corbel deterioration and infiltration.

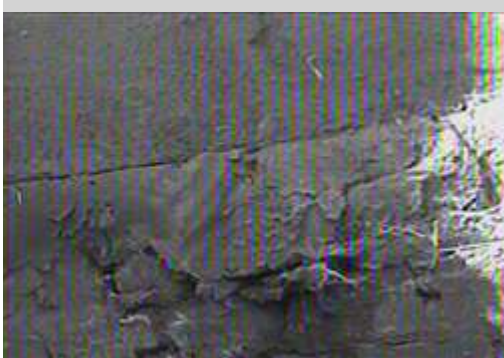
Defect

Frame leaks. Adjustment deterioration and infiltration.

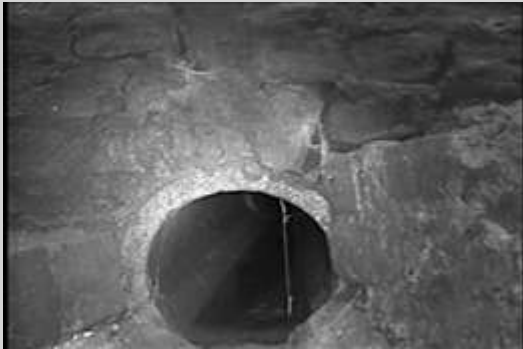
8 in. Circular Gravity Sewer Pipe Out @ 12 O'Clock

Barrel deterioration and infiltration. Channel deterioration.

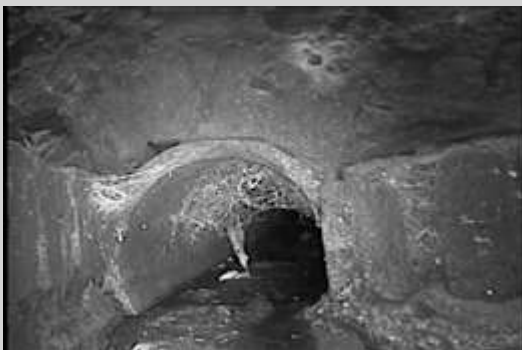
Pipe In @ 9 O'Clock

Channel and pipe debris.

Deposits: ☐ None ☒ **Mud** ☐ Sludge ☒ **Debris** ☐ Grease

Silt Depth: **0.5** (in.) Deposits Extent: **Light**

Infiltration: **Evidence**

Pipe Seal Cond: **Cracked**
